Medicine Lodge Creek Subbasin Total Maximum Daily Loads

2016 Addendum and Five-Year Review

Hydrologic Unit Code 17040215

February 2016

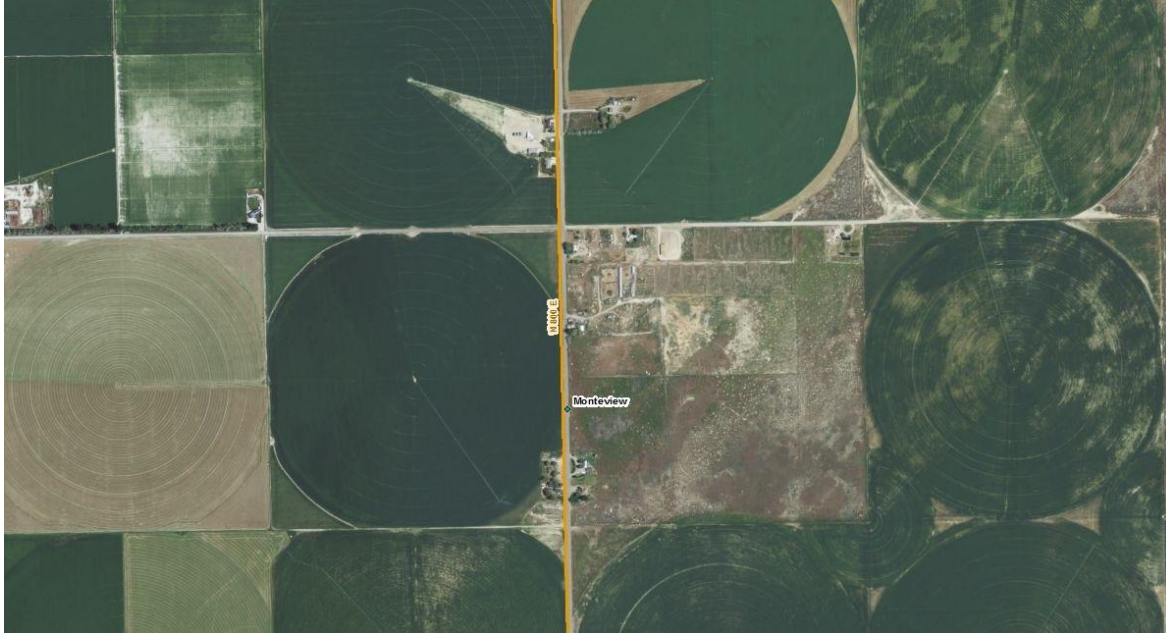
Figure 6. Montevieu, Idaho—only town in Medicine Lodge Creek subbasin.

The land area in this subbasin is all rural, lying mainly within Clark County. Montevieu, an unincorporated community shown in Figure 6 is the only town within Medicine Lodge Creek subbasin. According to the National Agricultural Statistics Service (2012), within the Montevieu zip code, there is a population of 512 people with 32 farm operations.

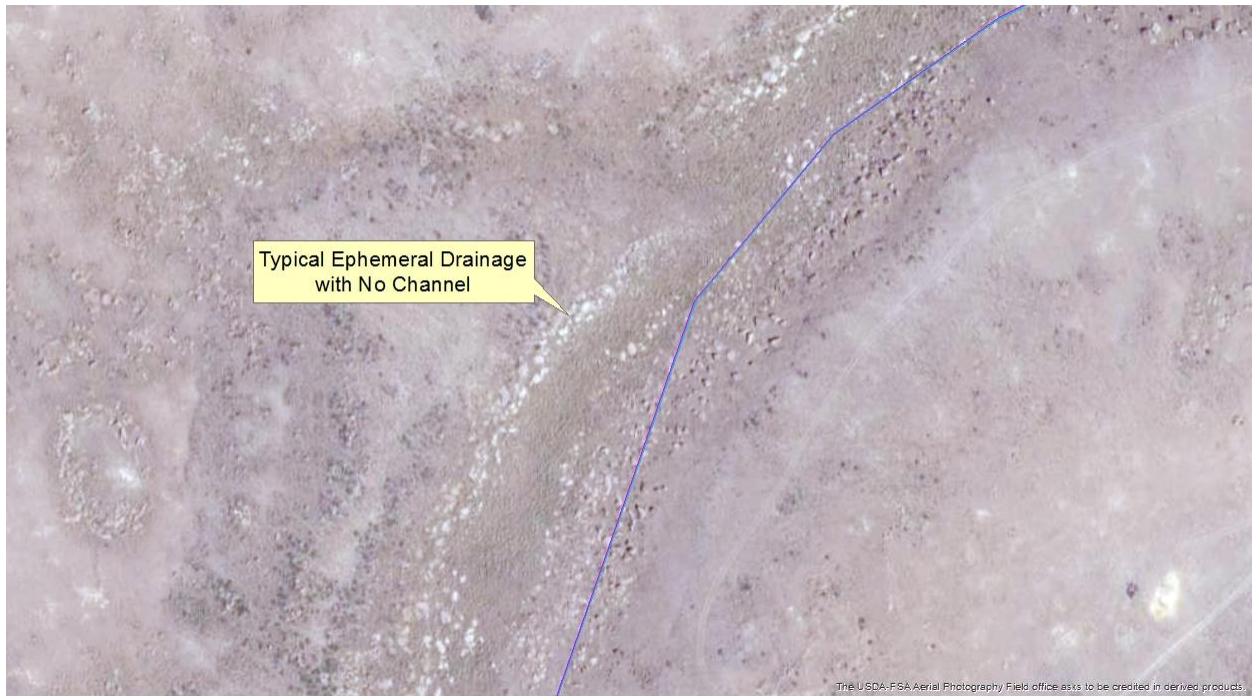
Figure 12. Ephemeral drainage without channel indicating a lack of water in the Medicine Lodge Creek subbasin (1:2000).

Portions of AUs in the shade analysis were identified as ephemeral waters through aerial photo interpretation and field verification. Two types of ephemeral waters were discovered: those with channels indicating water movement during the snowmelt period (Figure 11), and those with no channel suggesting water has not been there for some years (Figure 12). These areas are contrasted with small perennial waters where occupied channels are clearly visible (Figure 13).

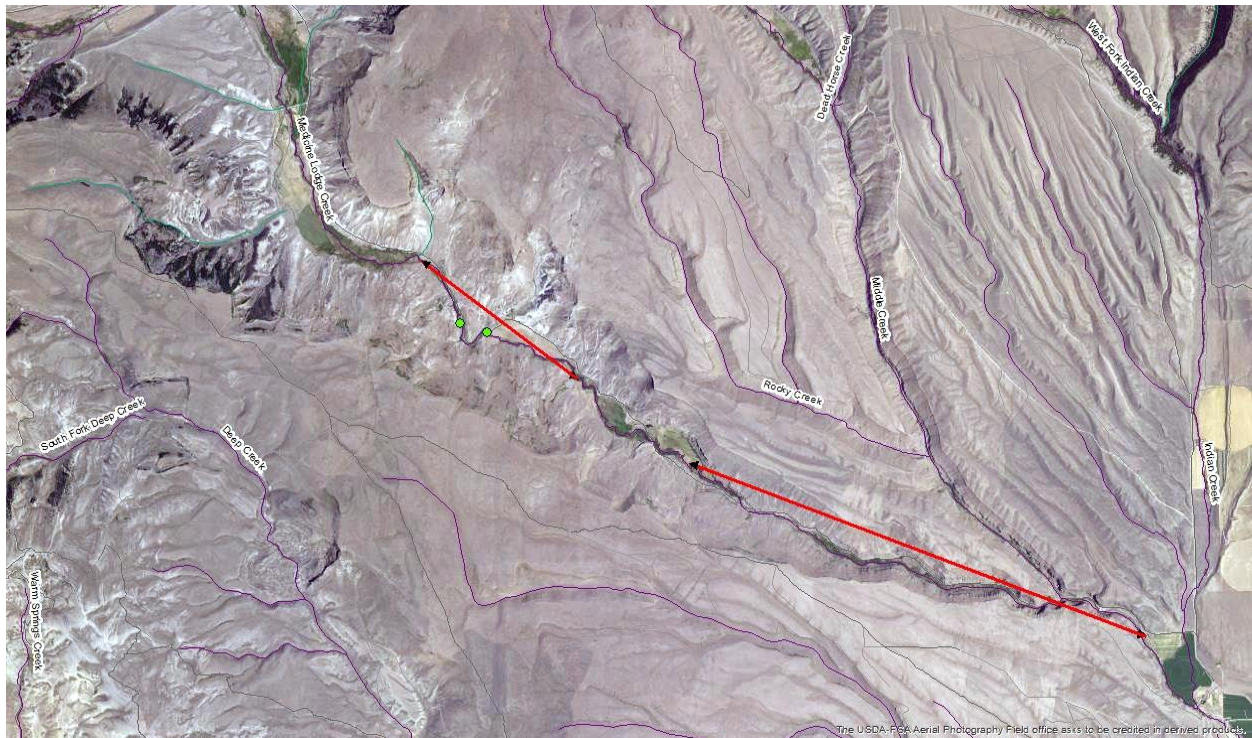
Figure 14. Map of the monitoring locations (between green dots) for Medicine Lodge Creek (ID17040215SK006_04). Length of similar stream is shown with red line.

A map and photo of the SEI monitoring location for Medicine Lodge Creek, ID17040215SK006_04 are shown in Figure 14 and Figure 15. Assessment efforts have focused on an area of Medicine Lodge Creek typical of the lower canyon. DEQ found no evidence of eroding streambanks in this portion of Medicine Lodge Creek. Lateral recession rate scoring was not greater than expected, and the amount of erosive bank was not greater than the 20% threshold typical of natural bank stability estimates.

As shown on the SEI calculations in Appendix D, out of 933 meters of streambank inventoried, 1.6% exhibited erosion, and this can be extrapolated to 13,260 meters of similar stream. The results are a total sediment load of 1.4 tons per year, which is less than the assimilative load capacity of 152.7 tons per year. A McNeil core depth fine sample was taken just upstream from the SEI reach. Mean depth fines (without 2.5-inch particles) were 21%, which is less than the 28%–33% maximum expected under natural conditions. Surface fine data from the pebble counts at the 2013 BURP site were 11% or less. Sediment impairment above natural background is not present in this stream segment.

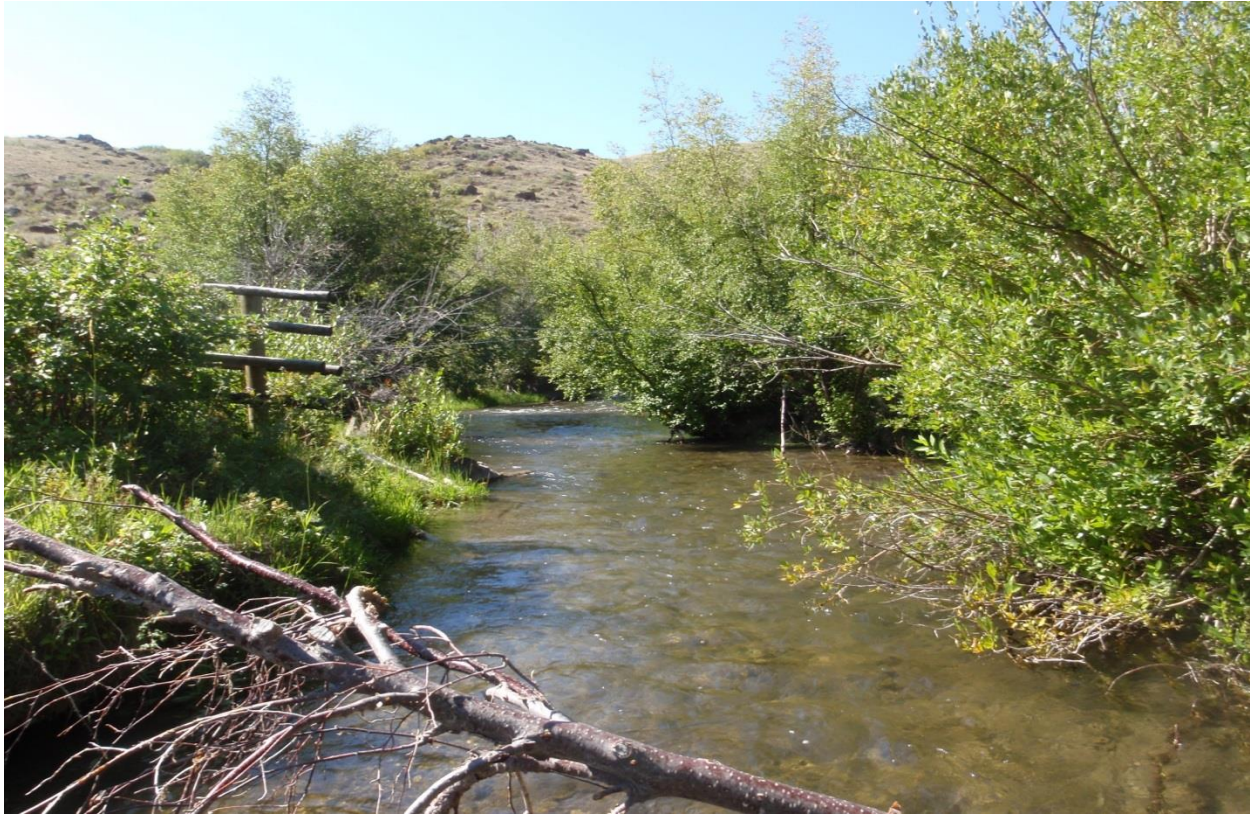
Figure 15. Sediment monitoring location for Medicine Lodge Creek (ID17040215SK006_04).

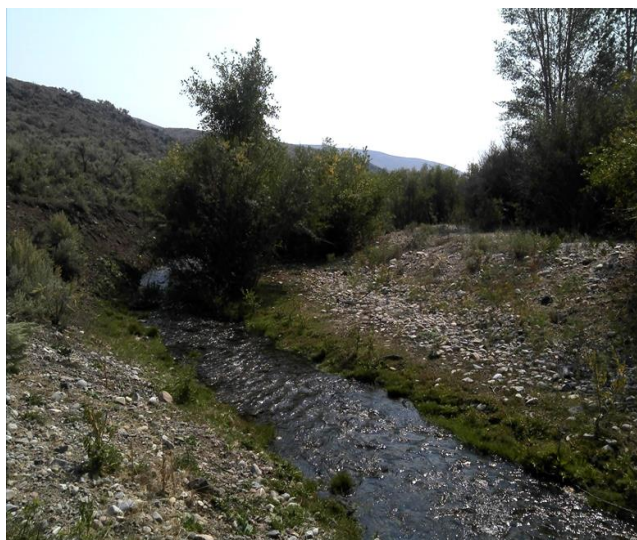
Photo 7

Figure 17, photos 7 and 8 are taken at the location of BURP site 2001SIDFA052 in the 3rd-order AU. The BURP site is located about 300 yards downstream of an unimproved ford. The stream is

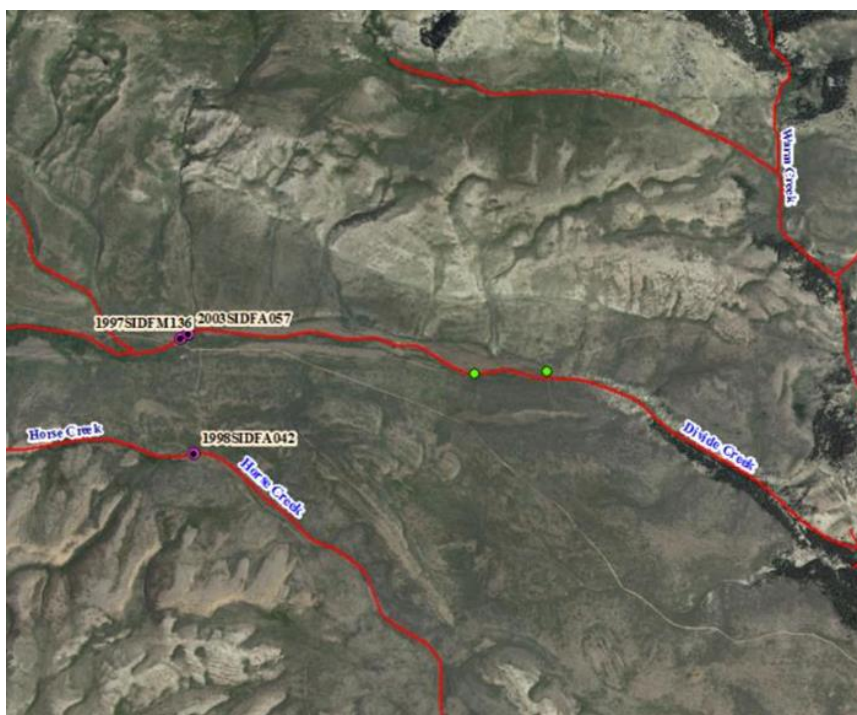
AU ID17040215SK014_02 Inventory location

Stream:	Divide Creek	Stream Segment Location (DD)	
Assessment Unit:	ID 17040215SK014_02	Upstream N	43.986340
Segment Inventoried:		W	-113.75707
Total Reach:		Downstream N	43.982990
Date Collected:	20-Jun-11	W	-113.75166
Field Crew:	A. Swift; T. Housley	Notes:	Adjacent land use BLM grazing and recreation; stable, few cut banks; not perennial enough for riparian vegetation; runs dry after spring runoff
Data Reduced By:	D. Sharp

High flow season 6/20/2011

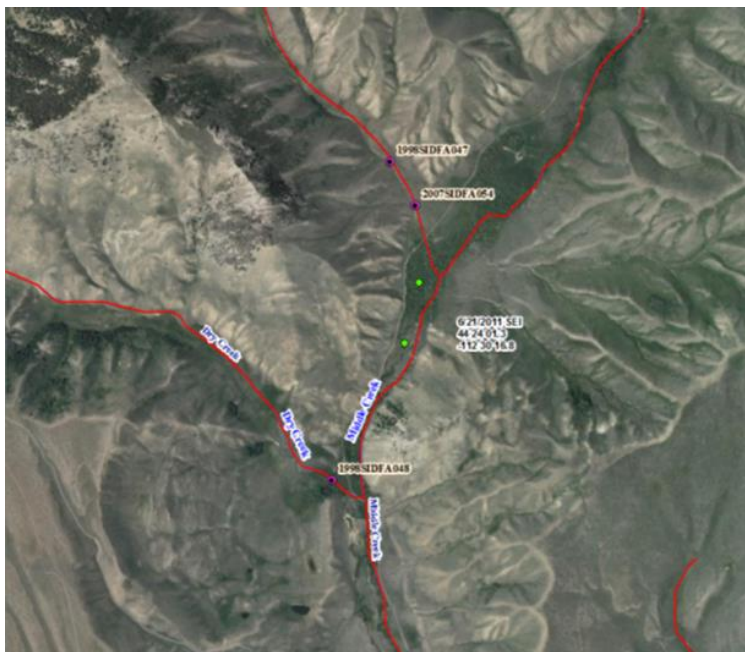
Stream:	Middle Creek	Stream Segment Location (DD)	
Assessment Unit:	ID 17040215SK008_02	Upstream N	44.399580
Segment Inventoried:	Mid-reach	W	-112.503986
Total Reach:		Downstream N	44.397765
Date Collected:	20-Jun-11	W	-112.50469
Field Crew:	A. Swift; T. Housley	Notes:	Cutbanks at start of SEI on upslope side from natural entrenchment; Even where constrained by the road, cuts are well-vegetated except one 2-meter reach.
Data Reduced By:	D. Sharp

Upper Middle Creek at the location of the SEI reach.

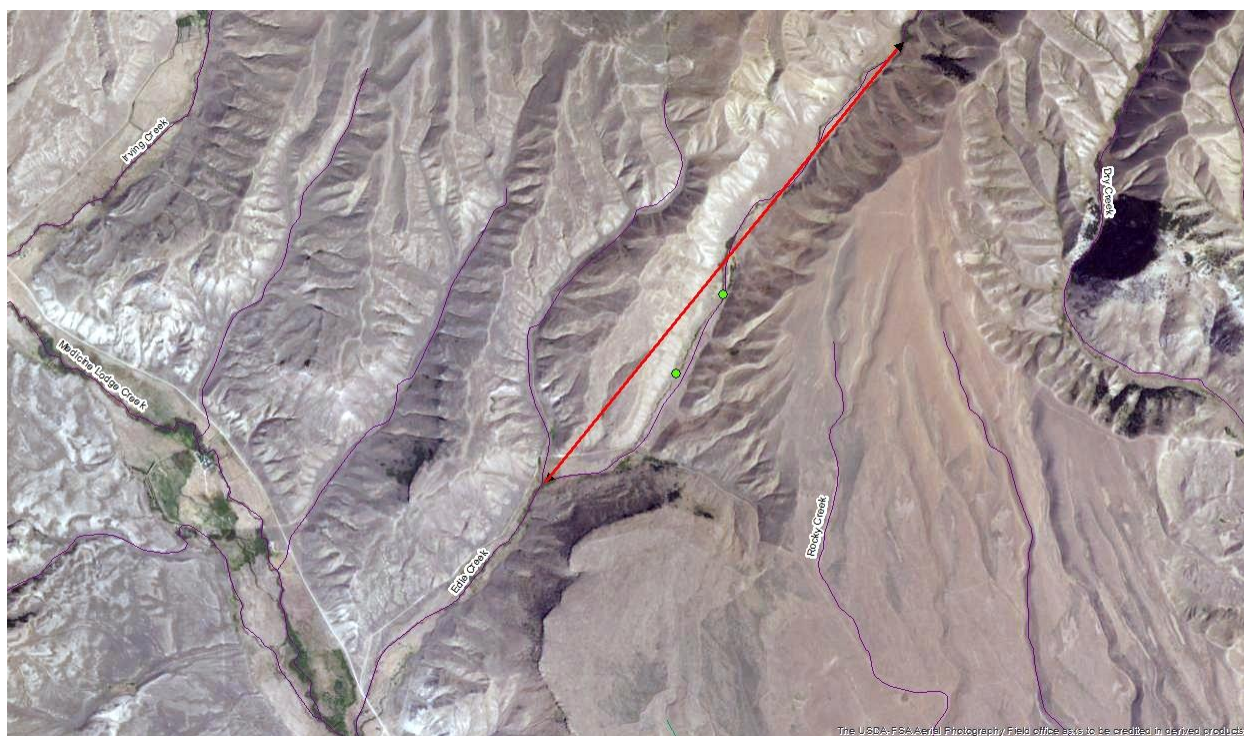
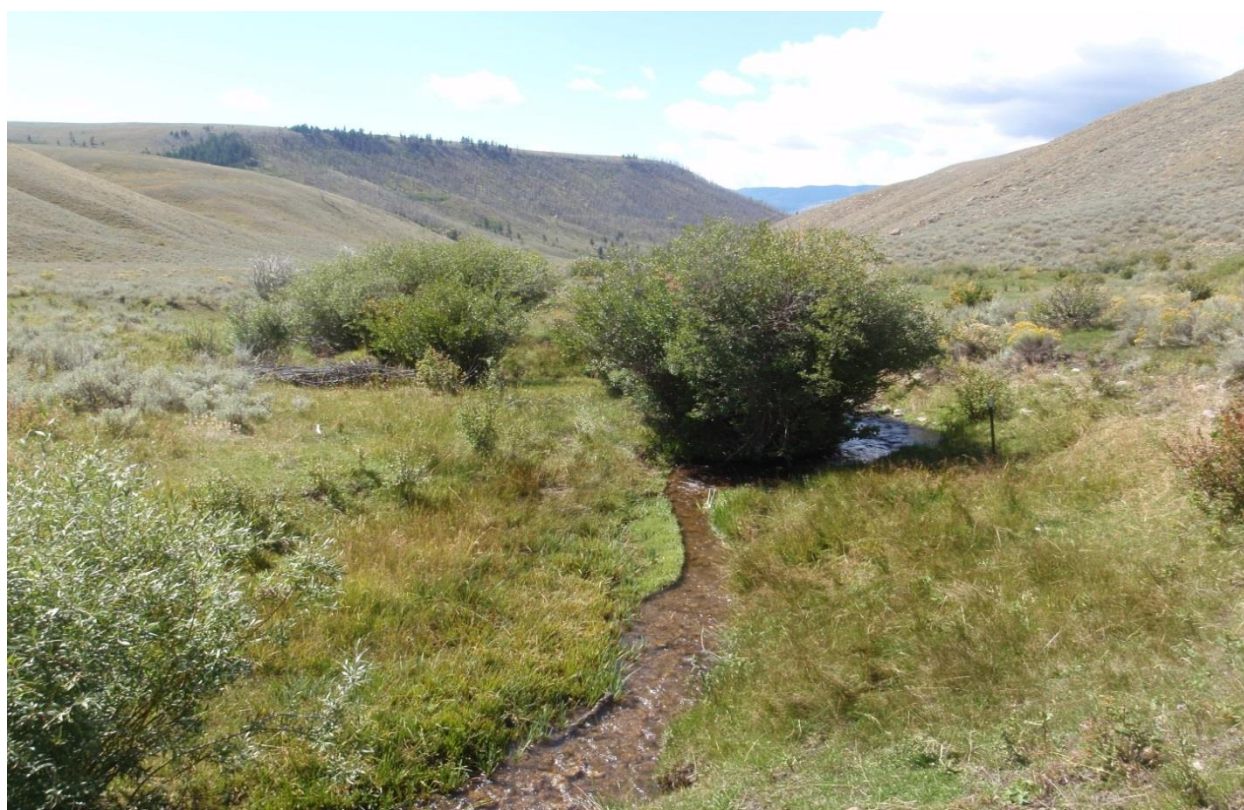
AU ID17040215SK010_02 inventory location.

STREAMBANK EROSION INVENTORY CALCULATION WORKSHEET					
Stream:		Edie Creek		Stream Segment Location (DD)	
Assessment Unit:		ID17040215SK010_02		Upstream N	44.406110
Segment Inventoried:		1500 ft above BLM boundary		W	-112.566930
Total Reach:		lower 1st order segment		Downstream N	44.400630
Date Collected:		26-Aug-14		W	-112.571950
Field Crew:		Curtis Cooper		Notes:	cattle grazing, recreation uses
Data Reduced By:		Mark Shumar

Current Load Streambank Erosion Calculations		Unit	Area Applied
Right, left or both bank measurements	2	Both Banks	Inventoried Segment
Inventory/Thalweg Length (LBB) (stream flowpath distance)	3100.00	ft	Inventoried Segment
TMDL Margin of Safety	10	%	Total Reach
Bulk Density (BD)	105	lb/ft ³	Total Reach
Length of Similar Stream	15059	ft	Total Reach
Estimated Distance inventoried	6200.00	ft	"
Total Erosive Bank Length	1170.00	ft	"
Percent Erosive Bank	18.9	%	"
Eroding Area (AE)	2049.00	ft ²	"
Lateral Recession Rate (RLR)	0.16		"
Bank Erosion (E)	17.21	tons/year	"
Total Bank Erosion Rate (ER)	29.32	tons/mile/year	Reach and Segment
Total Bank Erosion	83.61	tons/year	"

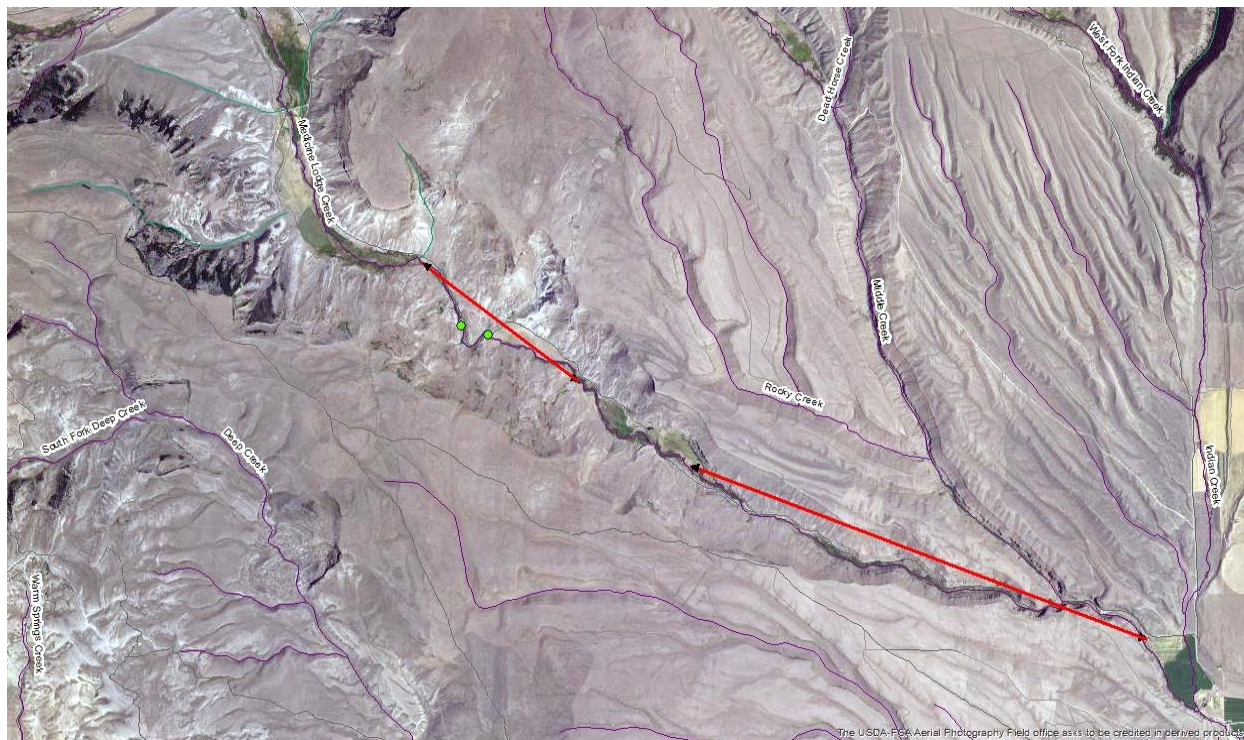
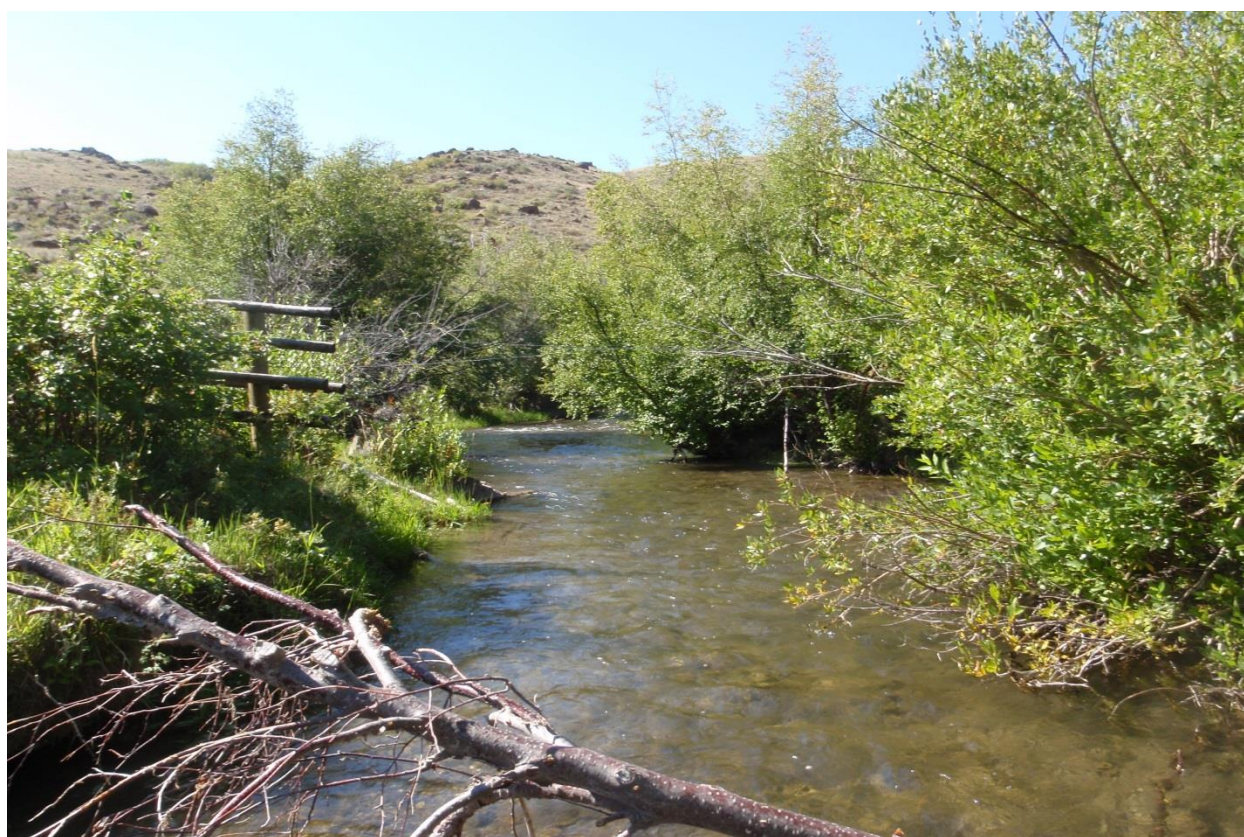
AU ID17040215SK006_04 inventory location.

STREAMBANK EROSION INVENTORY CALCULATION WORKSHEET					
Stream:		Medicine Lodge Creek		Stream Segment Location (DD)	
Assessment Unit:		ID17040215SK006_04		Upstream N	44.315721
Segment Inventoried:		BLM @ Re		W	-112.555300
Total Reach:				Downstream N	44.314380
Date Collected:		26-Aug-14		W	-112.549808
Field Crew:		Curtis Cooper		Notes:	basalt/limestone geology; grazing landuse
Data Reduced By:		Mark Shumar

Current Load Streambank Erosion Calculations		Unit	Area Applied
Right, left or both bank measurements	2	Both Banks	Inventoried Segment
Inventory/Thalweg Length (LBB) (stream flowpath distance)	3260.00	ft	Inventoried Segment
TMDL Margin of Safety	10	%	Total Reach
Bulk Density (BD)	105	lb/ft^3	Total Reach
Length of Similar Stream	43832	ft	Total Reach
Estimated Distance inventoried	6520.00	ft	"
Total Erosive Bank Length	102.00	ft	"
Percent Erosive Bank	1.6	%	"
Eroding Area (AE)	112.80	ft^2	"
Lateral Recession Rate (RLR)	0.0175		"
Bank Erosion (E)	0.10	tons/year	"
Total Bank Erosion Rate (ER)	0.17	tons/mile/year	Reach and Segment
Total Bank Erosion	1.39	tons/year	"
